# *Interim Report on the Examination of Corrosion Damage in Homes Constructed With Imported Wallboard: Examination of Samples Received September 28, 2009*

**D. J. Pitchure, R. E. Ricker,  
M. E. Williams, and S. A.  
Claggett**

Metallurgy Division,  
Materials Science and  
Engineering Laboratory,  
National Institute of Standards  
and Technology,  
Gaithersburg, MD 20899-8553

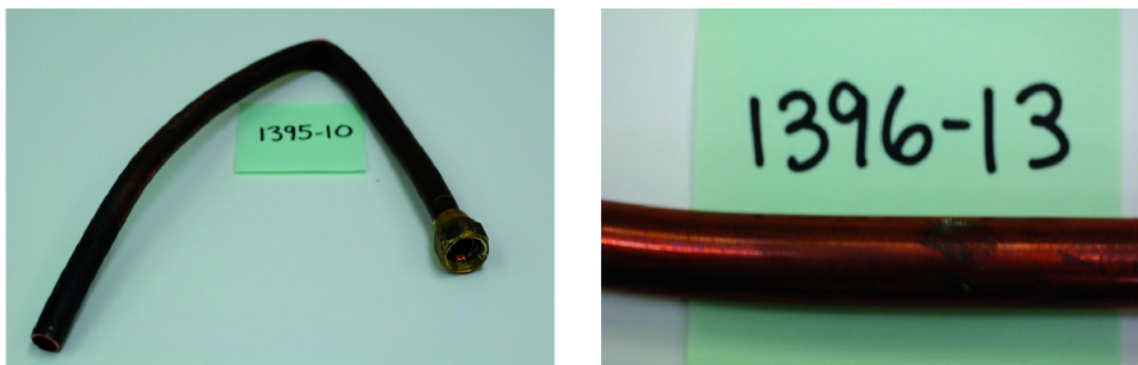
The lengths of copper tubing were discolored to varying degrees. This discoloration, which is illustrated in Fig. 1, was found to be due to the presence of a thin adherent layer of a black substance. This is clearly illustrated in Fig. 2 where the sample number has been scribed into the sample exposing fresh bare copper. The contrast in this figure is obvious. While this film adhered to the surface, physical contact would result in the transfer of a small quantity of a fine black powder from the film. In some cases, the discoloration was found to be very uniform, but in other cases it was irregular. The extent of discoloration varied with the thickness of the layer.

**Fig. 1.** Photographs of two representative samples of copper natural gas supply tubing.

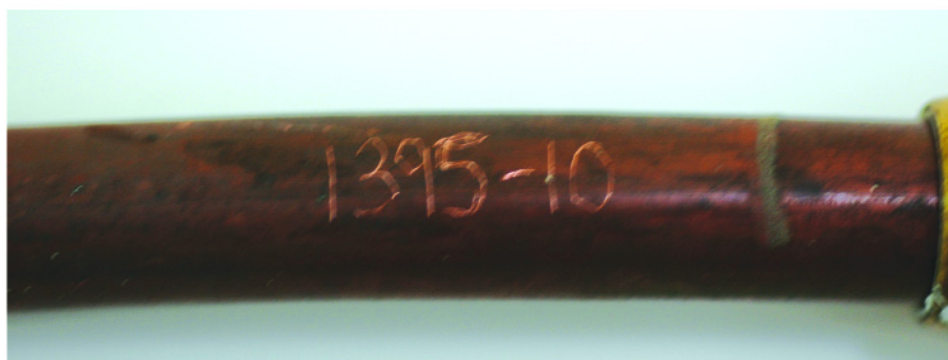
**Fig. 2.** Scribe marks illustrating the contrast between the color of bare copper and a sample of copper natural gas line tubing.

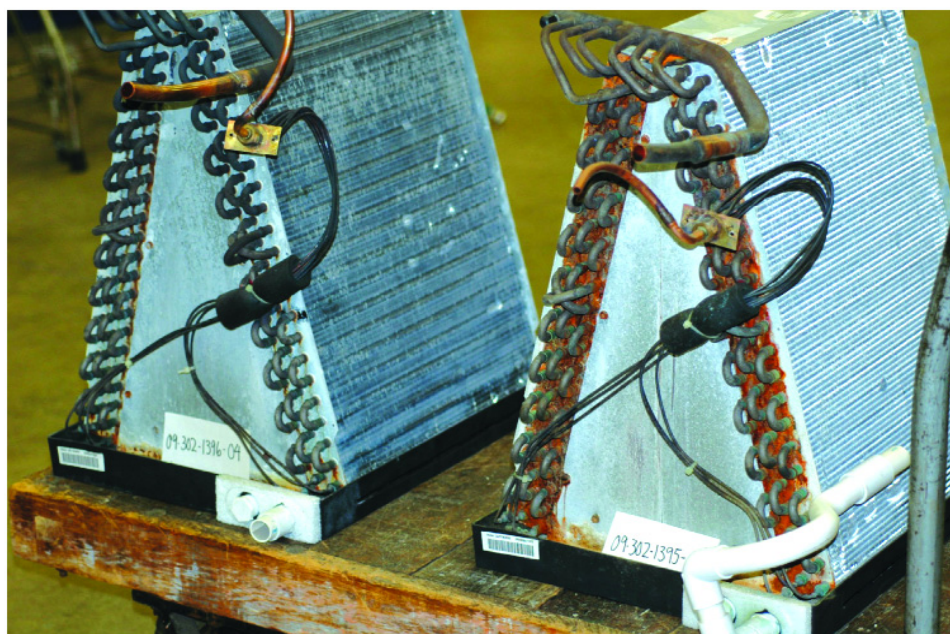
The air conditioner evaporator coils were also examined, Fig. 3. From the two coils in this figure it can be seen that all exposed copper surfaces have turned dark. These coils are constructed out of parallel lines of copper tubing placed through thin sheets of aluminum that serve as the heat transfer fins. The copper tubing is linked together by soldered U-bends to the ends of adjacent lengths of copper tubing. The end plates that hold this assembly in place are made out of galvanized steel. Copper manifolds and valves complete the assembly. Figure 4 is a close-up of the end plates and the U-bend region. In this figure, brown and orange corrosion products can be seen on the galvanized end plates, while black and green corrosion products can be seen on the copper tubing. The normal patina that forms on copper in the cyclically wet and dry environment of an air conditioner evaporator coil would be expected to contain copper (I) or copper (II) ions in oxides (black to brownish-red), carbonates (green to blue), sulfates (bright blue), and chlorides (greenish white to blue-green) [1,2]. Again, the black color was found to be due to the presence of a thin layer of a loose black powder.

**Fig. 3.** Photograph of the two air conditioner evaporator coils showing the black discoloration of the copper U-bends and corrosion of the end plate.

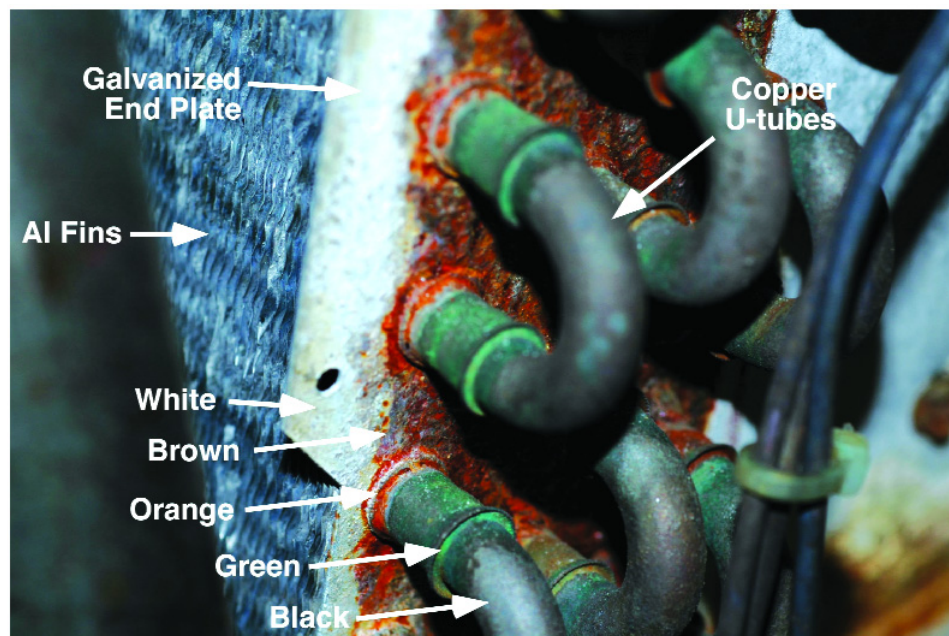
**Fig. 4.** Close-up photograph of the U-tubes and end plate of an air conditioner evaporator coil showing that there appears to be 5 colors associated with the corrosion products: white, brown, orange, green, and black.

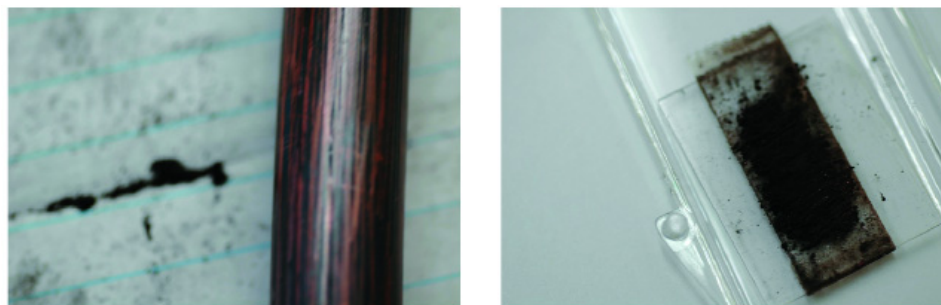
Fig. 5. Photographs of the scraped copper natural gas supply line and the slide holding the sample for x-ray diffraction.

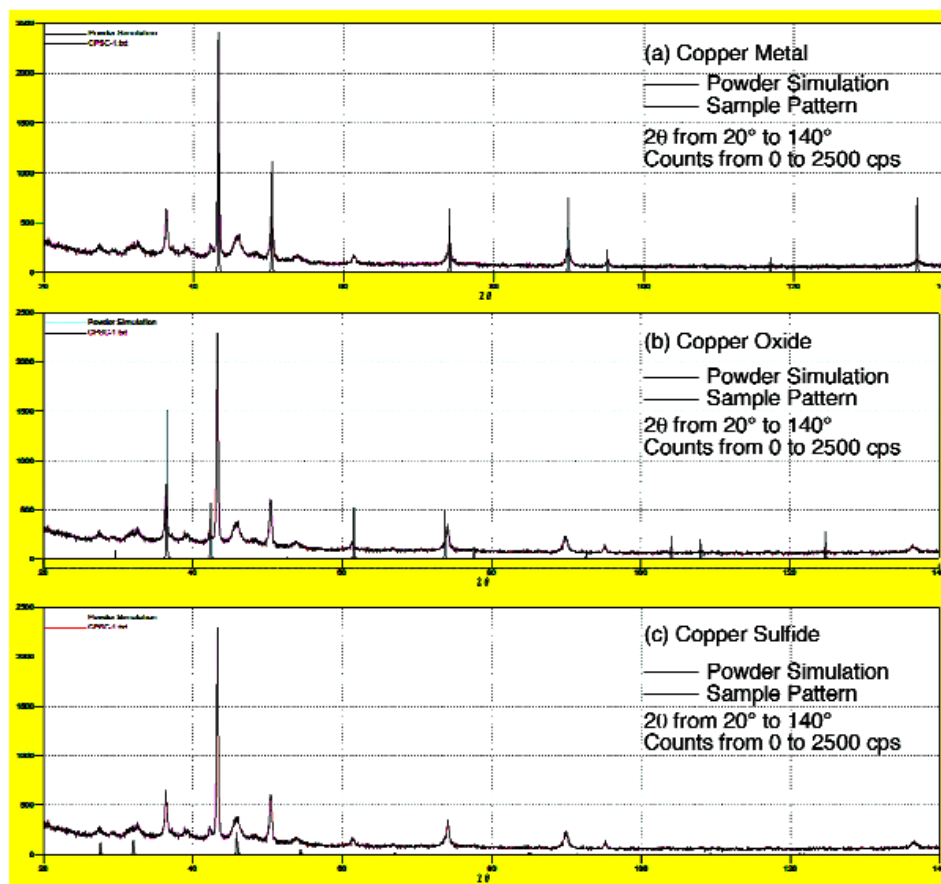
Figure 6 shows the results of these measurements in red along with the peak locations in black for copper metal (Fig. 6a), copper (I) oxide (Fig. 6b) and

copper (I) sulfide (Fig. 6c) as listed in the International Crystal Structure Database (ICSD). This figure shows that peaks corresponding to all three of these phases are present in the sample of scrapings from the surface of the copper natural gas supply line. Given that the sample was collected by scraping the surface of copper metal with a sharp razor blade, the peaks for copper and copper oxide were expected since copper is a soft metal compared to the steel of the razor blade and will normally form copper oxide when exposed to air. The third phase, copper sulfide ( $\text{Cu}_2\text{S}$ ) is not a typical atmospheric corrosion product as the concentration of the reduced sulfur species, such as  $\text{H}_2\text{S}$ , required to form this product is usually very low under normal atmospheric conditions [1, 3-5]. Figure 7 is a summary of the XRD results showing that all but two small peaks, indicated by question marks, are accounted for by these three phases.

Fig. 6. Powder diffraction patterns for the sample of corrosion products scraped off a copper natural gas supply line (red) with, identified in black, the peaks for (a) copper, (b) copper (I) oxide (ICSD #38233), and (c) copper (I) sulfide (ICSD #95395).

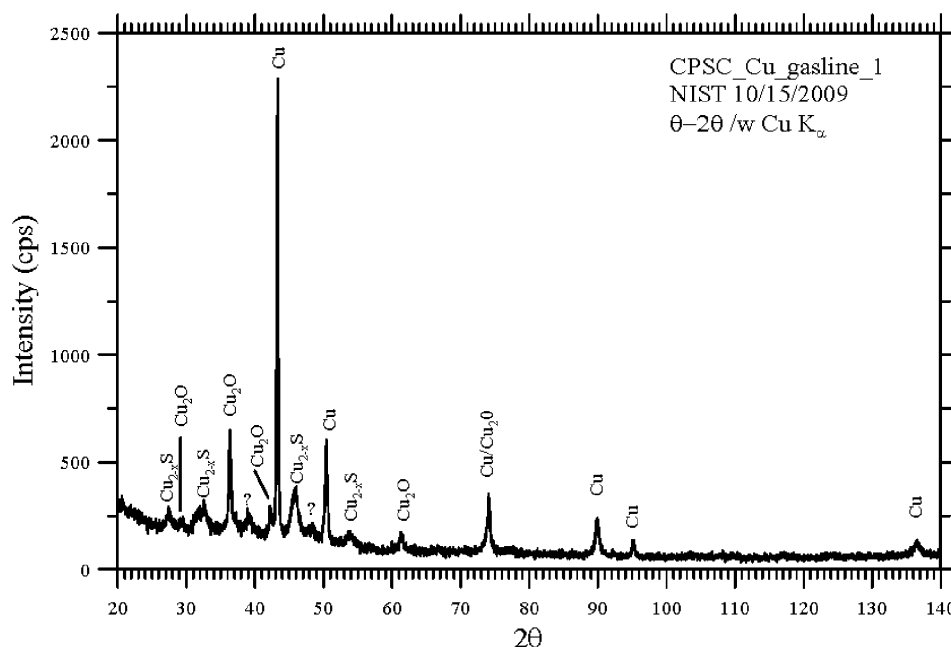
Fig. 7. Summary of peaks found in the corrosion product sample and their identification for showing that only two small peaks were unidentified by the three phases.

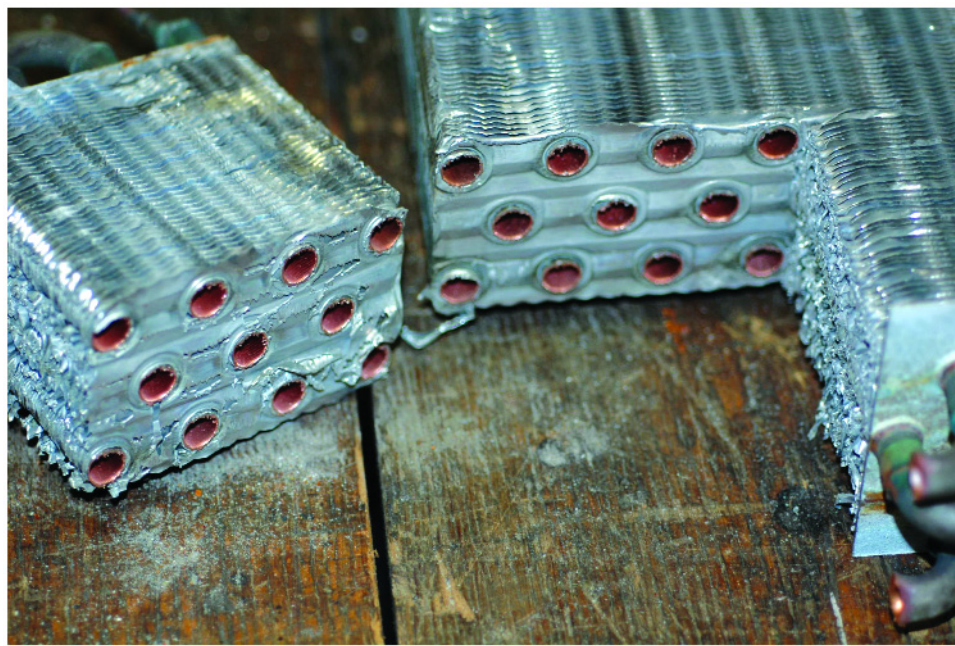
was sliced with a band saw as shown in Fig. 8 to expose these internal surfaces for examination of the copper. No evidence of localized attack was found, and the black corrosion product layer was not detected by visual examination.

**Fig. 8.** Air conditioner evaporator coil after slicing to allow for examination for corrosion damage between the aluminum sheets and the copper tubing.

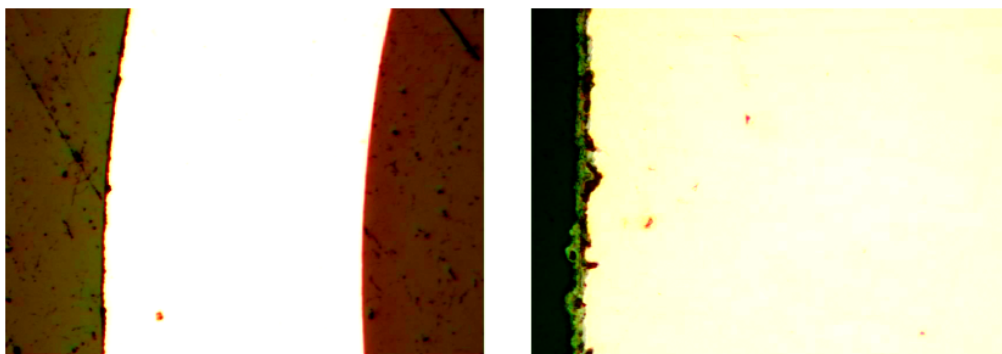
The thickness of the black corrosion product was measured using optical microscopy of samples prepared in cross section. For this analysis, samples of natural gas supply lines were cut, mounted in epoxy, and polished using standard metallurgical practice, exercising care to maintain the edge of the sample with the corrosion products in place. Figure 9 shows optical micrographs of this sample where the corrosion product layer varied from 5  $\mu\text{m}$  to 10  $\mu\text{m}$  thick.

**Fig. 9.** Optical micrographs of the wall of a copper natural gas supply line and the corrosion product layer at two magnifications (wall  $\approx 1.2$  mm thick).
